## Siltation from Construction Runoff: Using In-Situ Inc. MP TROLL 9000™ to Monitor Silt Laden Runoff From Construction Activities

Rob Toole - Tennessee Izaak Walton League Erosion Control Specialist

### Project Overview

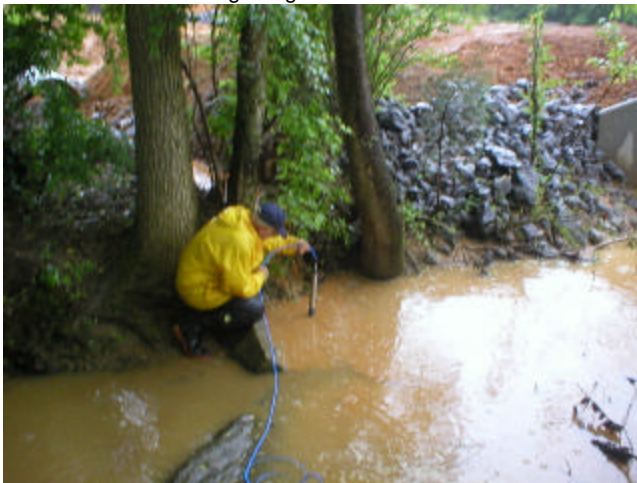
Urban Stream Monitoring using MP TROLL 9000

**Equipment:** The In-Situ MP TROLL 9000, 25 ft of Quick-Connect cable and Pocket-Situ software running on a ruggedized iPAQ color PDA was used to take snapshot readings. Data was uploaded onto a desktop computer and printed for analysis.

**Procedure:** The MP TROLL 9000 was calibrated before leaving the office. Upon arrival the TROLL 9000 was deployed in the creek at 6 different locations along the creek. A snapshot was taken at each site.
